## TEST REPORT

No. : GZIN1903010616MR

Sample Name : WATER PROOF PLUG(SMALL)

### Summary of Results:

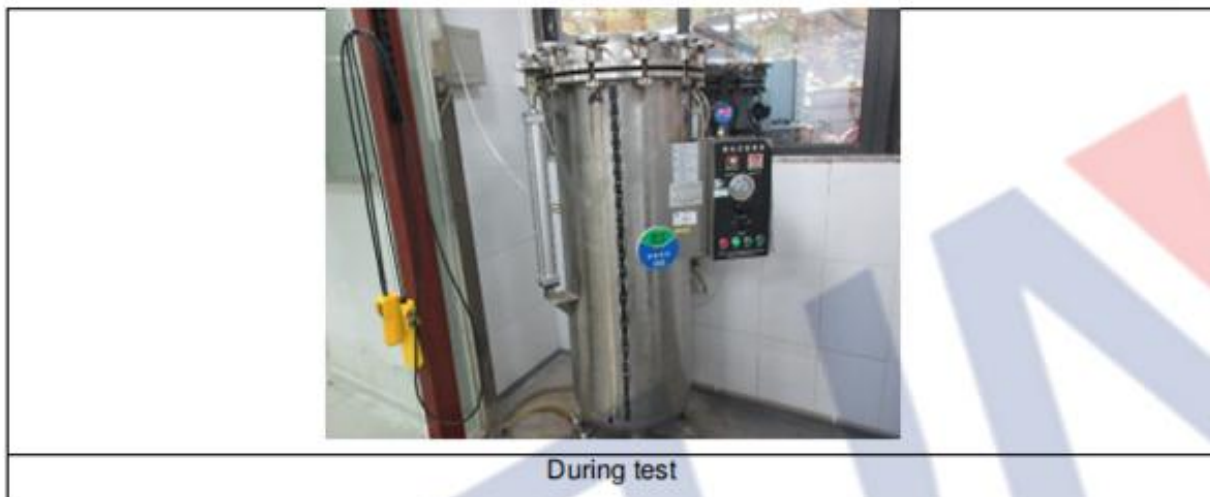
Test Photo:

Depth: 2 m (1.0 m water depth and 0.01 MPa air pressure)

Test duration: 30 min

| Sample | Result | Client's requirement | Conclusion |
|---|---|---|---|
| A-#2 | No visual ingress of water | No visual ingress of water | Pass |
